# THE DELIVERY OF DHT LEOPARD & DHT LION

JUNE 2016 EDITION

# **IMPROVING MOTOR BEARING RELIABILITY**

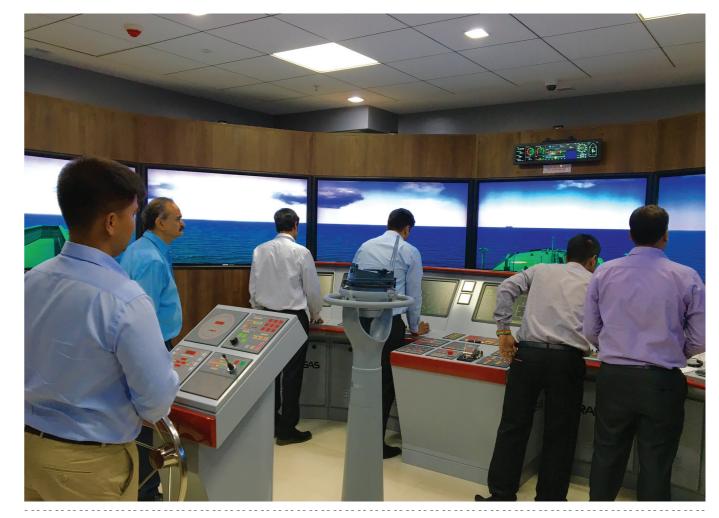
Full Mission Bridge Simulator

Transas full mission bridge simulator has also been upgraded to its latest version of NTPRO 5000 version 5.35. It offers a new mechanical interaction which will improve simulation in berthing, un-berthing and close quarter ship handling exercises to enhance our training on situational awareness courses. The enhanced stability and quality of fendering operations modelling will improve our Ship to Ship exercise experience. Realistic grounding and stuck scenarios modelling will improve the better grounding simulation in case of grounding exercise. This new version will also provide a better overall graphical experience as compared to the previous version 5.25. The first situational awareness (SAC) course was conducted on the upgraded version in April 2016.

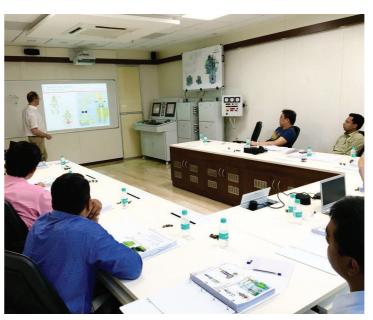
New Classroom and ME Electronic Engine Simulator

We have also upgraded our training facilities We are happy to announce that MAN B&W ME Electronic Engine simulator has been installed and commissioned in the new premises. In addition to other courses the Electronic Engine

simulator training has been commenced from 14th March 2016. The first ME course was conducted for a period of five days from 14 March 2016 – 18 March 2016. This course covers the following aspects of the Electronic Engine:

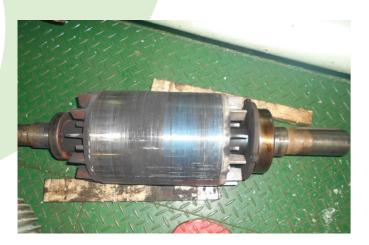
Overgreasing rolling element bearings in motors has been a perennial issue. More motors have bearing failures due to overgreasing than from undergreasing. Rolling element bearings used in electric motors are at risk for various modes of failure if an incorrect maintenance or lubrication strategy is implemented. These include incorrect lubricant selection, contamination, loss of lubricant and overgreasing
